Voyager Bulletin

MISSION STATUS REPORT NO. 69 JUNE 20, 1985

Scan Platform Is Healthy

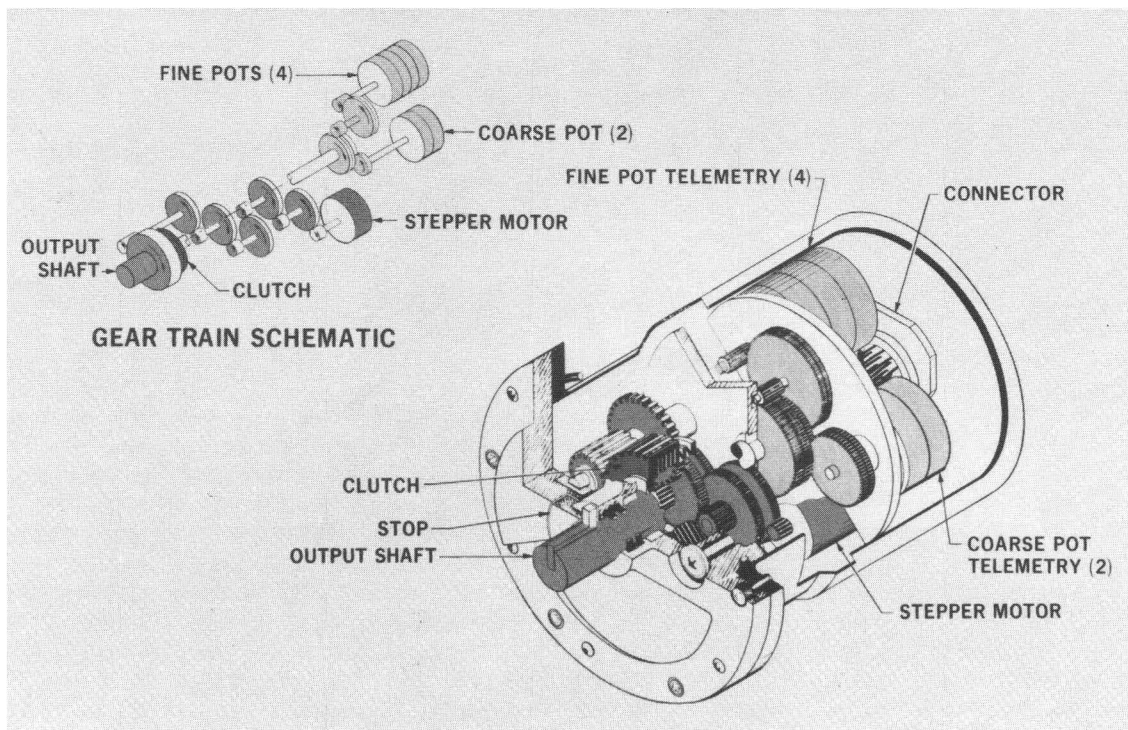
The actuator problem is attributed to a lack of full lubrication in the bearing areas. Lubrication appears to have migrated back, healing the problem.

The final report on ground testing of the actuator attributes the failure to a lack of full lubrication of the bearing area between the gear and pin. Frictional heat builds up and causes the lubricant to become less viscous, leave the bearing area, and allow metal to metal contact. A complex chain of chemical reactions between the lubricants and materials also contributes to the manufacture of debris which then interferes with free motion.

It is speculated that the lubricant has migrated back to the bearing surfaces, thus healing the problem.

At Uranus, the platform slews will be primarily at low rate with a small number of medium rate slews for critical science observations. Eight roll turns have been substituted for large angle slews where possible. If there are any indications of problems just prior to the intensive encounter phase, a computer program will be sent to the spacecraft to substitute spacecraft roll turns for azimuth slews.
