AEROSPACE

NOAA searches for solution to GOES-17 camera issue

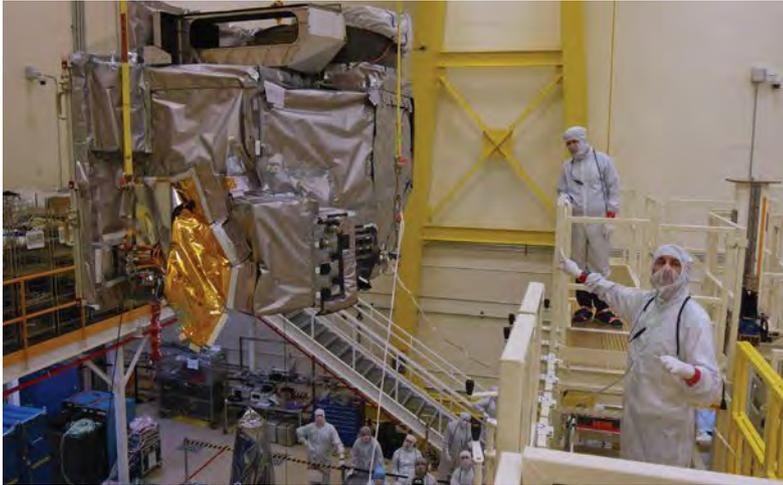
▲ Engineers install the main camera on the GOES-S (now GOES-17) satellite. With that satellite in orbit, its main camera, the Advanced Baseline Imager, isn't working in the middle of the night over the United States.

ABI's thermal control system is not cooling the imager's 13 infrared and near infrared detectors to the required temperature of minus 213 degrees Celsius, just 60 degrees above absolute zero. During the night when the camera is pointing at the U.S., the sun is directly behind Earth and some sunlight shines directly into the lens, heating it up. Cooling is necessary so that infrared energy from the atmosphere stands out when it reaches the detectors that must convert the faint infrared energy into electrical signals and measurements.

The cryocooler is overheating because the loop heat pipes are not transferring heat to the radiator, said Sullivan. "The thermal load increases [each day] to a point where we are not able to cool the detectors down," Sullivan said during the press briefing. The team must "understand the loop heat pipe behavior and isolate the cause of the problem," Sullivan said in a written response to my questions.
