September 2013

A PUBLICATION OF THE AMERICAN INSTITUTE OF AERONAUTICS AND ASTRONAUTICS

Space station repair: How it's done

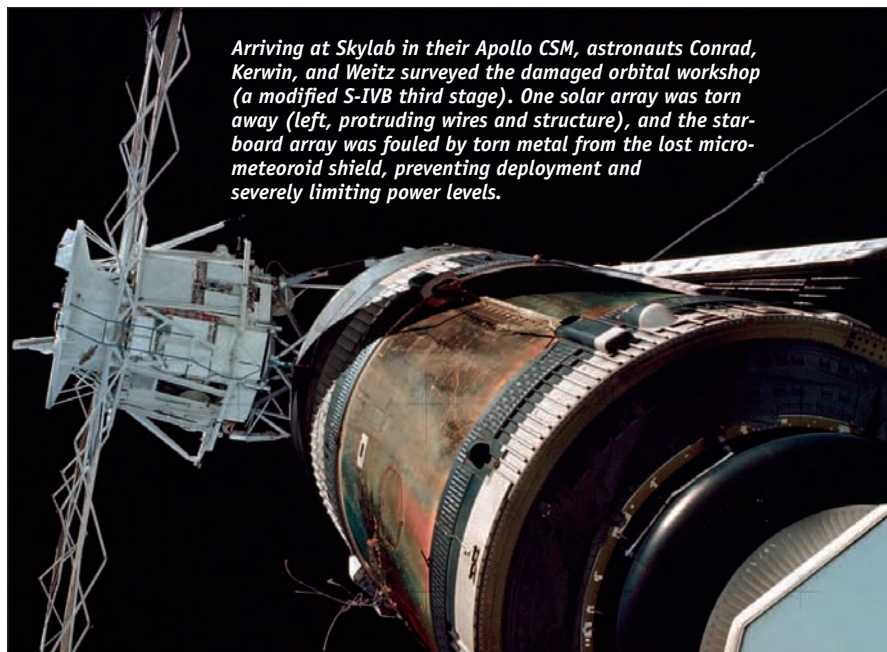
Arriving at Skylab in their Apollo CSM, astronauts Conrad, Kerwin, and Weitz surveyed the damaged orbital workshop (a modified S-IVB third stage). One solar array was torn away (left, protruding wires and structure), and the starboard array was fouled by torn metal from the lost micrometeoroid shield, preventing deployment and severely limiting power levels.

Standing in the hatch with Kerwin holding his legs, Weitz extended a 10-ft-long pruning hook toward the end of the array. "We thought maybe we'd just break it loose. So we got down near the end of the solar array and I got a hold of it with the shepherd's crook," said Weitz. "I positioned the hook under the end of the wing and gave a mighty heave."

ton CSM against the workshop, Conrad switched to an alternate approach: trying to cut through the metal strap binding the array. Beneath Weitz, Kerwin replaced the pruning hook with a lanyard-activated set of 'branch loppers.' Conrad eased back in, carefully moving the open hatch farther up the workshop near the solar array hinge. Again supported by Kerwin, Weitz tried to place the shears and cut the twisted metal strap, but "I could not get a good grip on the strap, or find enough purchase on it," he recalled. "We were trying to cut along the long way and just didn't have enough muscle with that thing, because it was about six or eight feet out ahead of me, and I was pulling on a line to try to do it; and we just could not get it through."

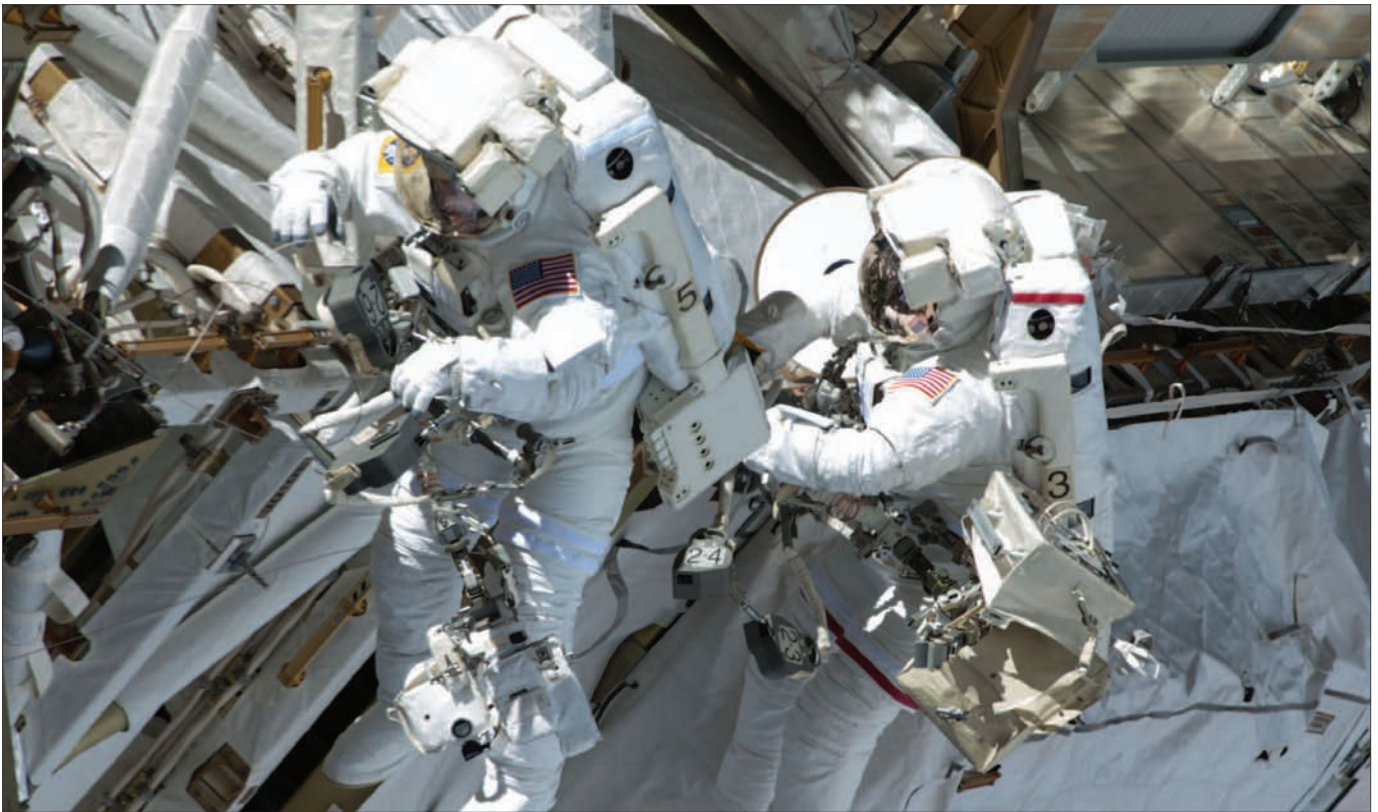
When the visible leak appeared in early May, engineers had their evidence. "The ammonia snowflakes did not appear to be coming from a point source," said Shireman. Rather than a micrometeoroid impact, engineers now suspected an internal leak in the loop's pump flow control subassembly (PFCS), which circulates ammonia through cold plates in the array electronics and out through the radiator.

Expedition 35 flight engineers Chris Cassidy (right) and Tom Marshburn completed a space walk on May 11, 2013, to inspect and replace a pump controller box on the ISS's far port truss (P6) leaking ammonia coolant.

On May 11 Marshburn and Cassidy, who had spacewalked together in 2009 on STS-127, translated to the far end of the P6 truss, then removed the dishwasher-sized PFCS. They saw no signs of frozen ammonia: "It looks really clean, surprisingly so," reported Cassidy. The astronauts parked the faulty pump, then installed a spare, older PFCS that had driven the loop for the first few years of ISS operations. Using pistol-grip power tools, the pair bolted the spare PFCS into the truss, then drove two shafts that tightly mated it to the 2B ammonia lines.

The reconnection went smoothly; ground controllers started the pump and checked the loop's integrity as the astronauts observed for half an hour. "I've had eyes on it and haven't seen a thing," Marshburn radioed. The system appeared to be holding. Their mission accomplished, the astronauts returned to the Quest airlock after five-and-a-half hours outside.
