# **History of Rocketry and Astronautics**

**Proceedings of the Twenty-Fourth Symposium of  
the International Academy of Astronautics**

# Engineering Development of the Apollo Lunar Module\*

Joseph G. Gavin, Jr.<sup>†</sup>

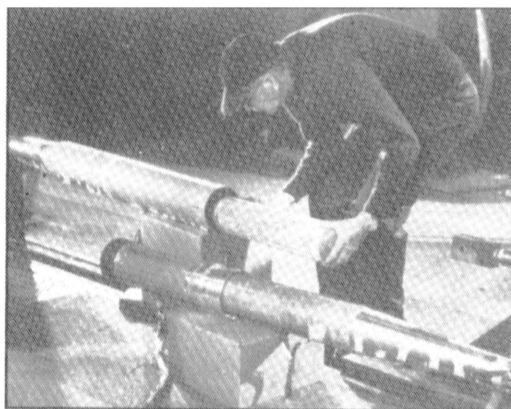
**Figure 4** Inserting the honeycomb shock absorber into the landing gear.

The landing gear was designed with a 32 in. stroke, using aluminum alloy honeycomb as the shock-absorbing medium (Figure 4). Actual experience showed a maximum deflection of 3 in., corresponding to a vertical sinking speed of about 2 fps.

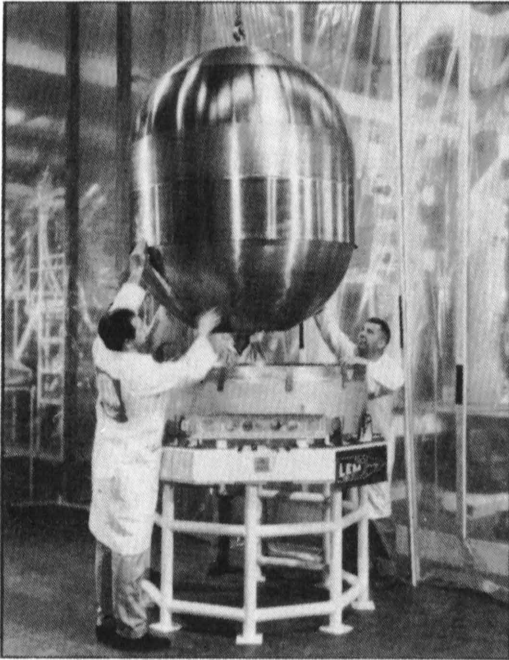
**Figure 21** Descent stage tank being mounted in its structural support.

The titanium alloy fuel tanks were mentioned earlier; Figure 19 shows the ascent tanks. Figure 20 shows how the swirl baffles were modified after extensive testing with referee propellants. Figure 21 shows a descent stage tank being mounted in its structural support. These tanks were so thin that filling the first of the flight-weight tanks produced consternation—the weight of the fuel stretched the tank enough to accept additional fuel, about 20 seconds worth, as I recall. This was very acceptable, when landing hover times were being planned at 140-150- seconds.
