NASA SP-126

SURVEYOR I

A Preliminary Report

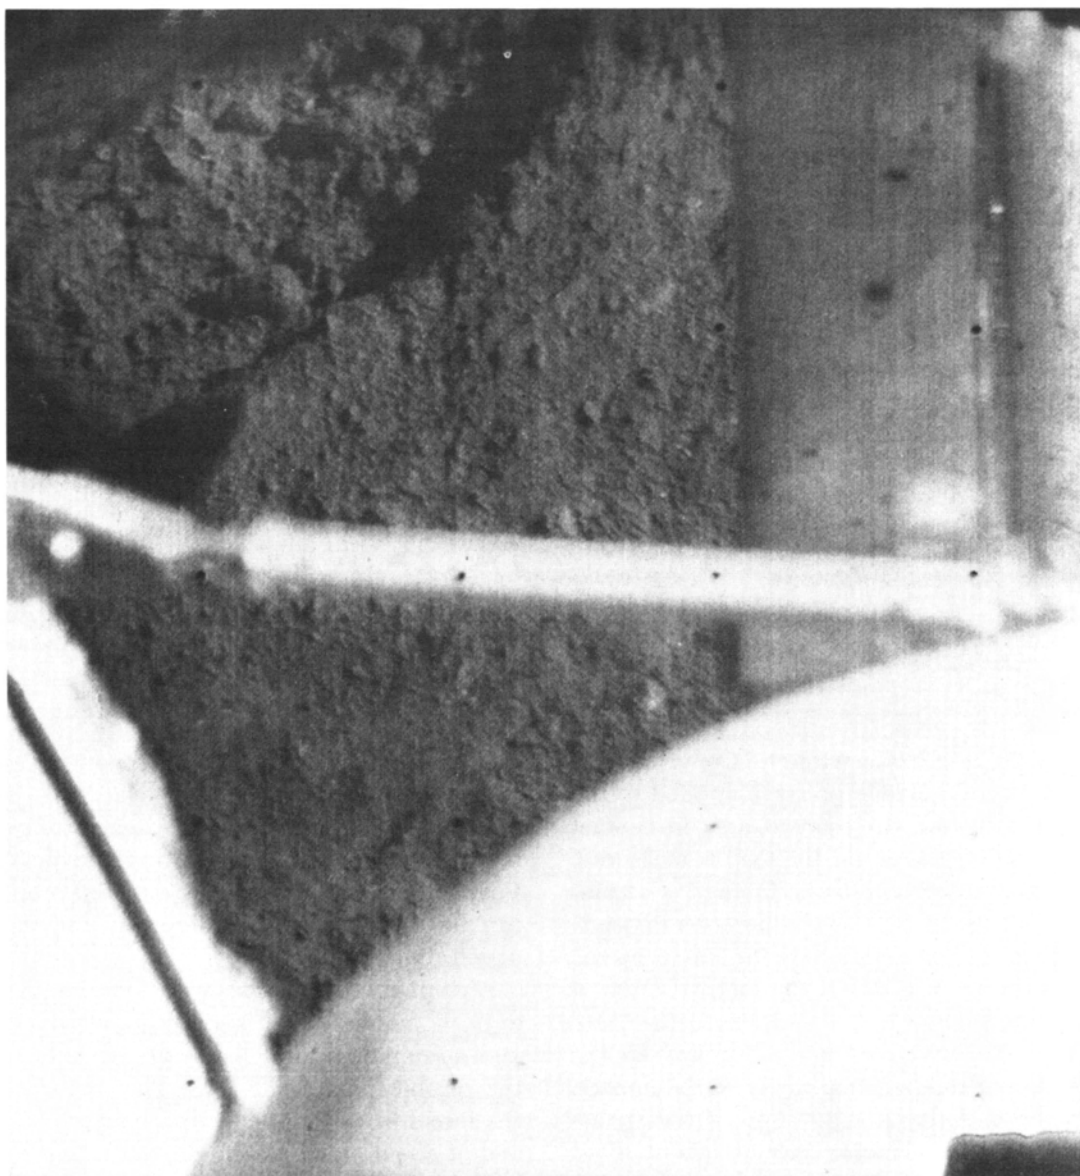
FIGURE 11.— Photograph of the surface depression made by crushable block 3. Note the depression made in the upper left-hand corner. Some parts of the spacecraft are shown.

A picture of a depression in the lunar surface under cylindrical crushable block 3 (see fig. 11) indicates that it also made contact with the lunar surface. At the date of this writing, it has not been possible to identify positively any lunar surface depression under crushable block 1. The area beneath crushable block 2, and the crushable blocks themselves, cannot be seen with the Surveyor TV camera. However, the symmetry of the impact and the general local flatness of the

lunar surface lead to the conclusion that all the crushable blocks made contact with the lunar surface. Measurements of shadows of the depression made by crushable block 3 indicate a depression depth of about $\frac{3}{8}$ in. (2 cm).
