Voyager Bulletin

MISSION STATUS REPORT NO. 69 JUNE 20, 1985

Scan Platform Is Healthy

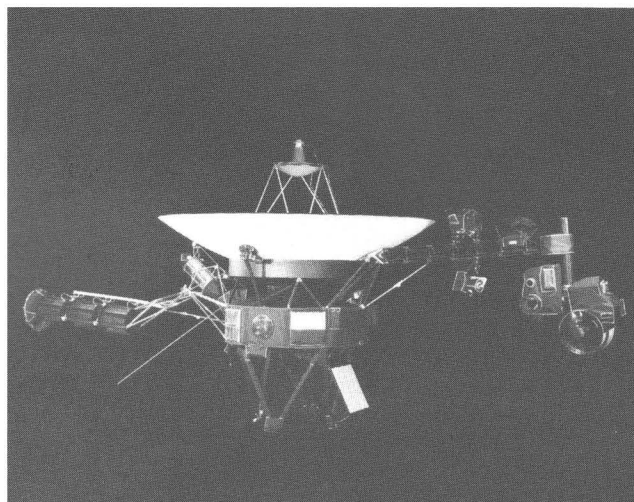
Fault protection routines onboard the spacecraft detected the failure and automatically commanded the platform to slew to a "safe" position to protect the delicate optics of the instruments from direct sunlight, but this slew also stopped short. The platform appeared to have seized in the azimuth axis.

Voyager's scan platform (far right) carries the wide- and narrow-angle cameras, ultraviolet spectrometer, infrared interferometer/spectrometer, and photopolarimeter.

The final report on ground testing of the actuator attributes the failure to a lack of full lubrication of the bearing area between the gear and pin. Frictional heat builds up and causes the lubricant to become less viscous, leave the bearing area, and allow metal to metal contact. A complex chain of chemical reactions between the lubricants and materials also contributes to the manufacture of debris which then interferes with free motion.

At Uranus, the platform slews will be primarily at low rate with a small number of medium rate slews for critical science observations. Eight roll turns have been substituted for large angle slews where possible. If there are any indications of problems just prior to the intensive encounter phase, a computer program will be sent to the spacecraft to substitute spacecraft roll turns for azimuth slews.

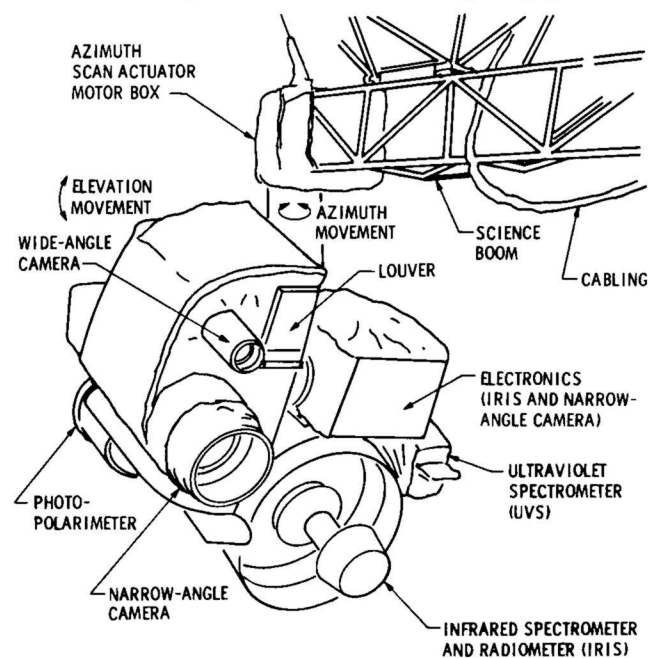
The scan platform can be rotated about two axes to provide precision pointing for its four remote sensing science instruments.
